Procedia Engineering 161 (2016) 1678 – 1682

World Multidisciplinary Civil Engineering-Architecture-Urban Planning Symposium 2016,
WMCAUS 2016

Evolution Study of Colours Throughout the History of Façades of the Royal Ordnance Factory of Seville

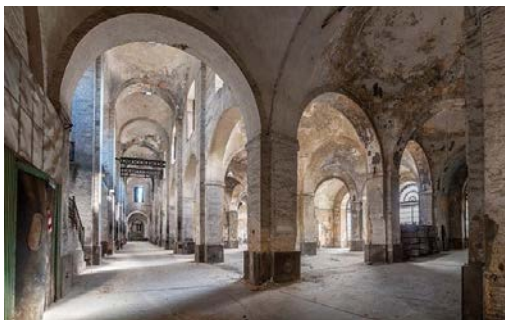
Fig. 1. Section known as "The Cathedral".

The term “colour” may refer not only to a certain region of the visible light spectrum but also to the materials in pigments and dyes, or, frequently, be used as a synonym for pigment or paint. Knowledge of the range of colours produced by light and pigments in the buildings of a city is necessary to understand life in the city during various time periods. Prior to the 19th century, decoration of façades was a characteristic architectural element in the Spanish city of Seville. The Royal Ordnance Factory of Seville, which is a complex structure with many different sections, is an example of industrial architecture in Seville. The section known as “The Cathedral” (see Figs. 1 and 2) is a spectacular
